# Accident of T-3 in KAGRA Y-arm tunnel

Nobuhiro KIMURA (ICRR)

2021/Dec./16

# Incident of vacuum leakage

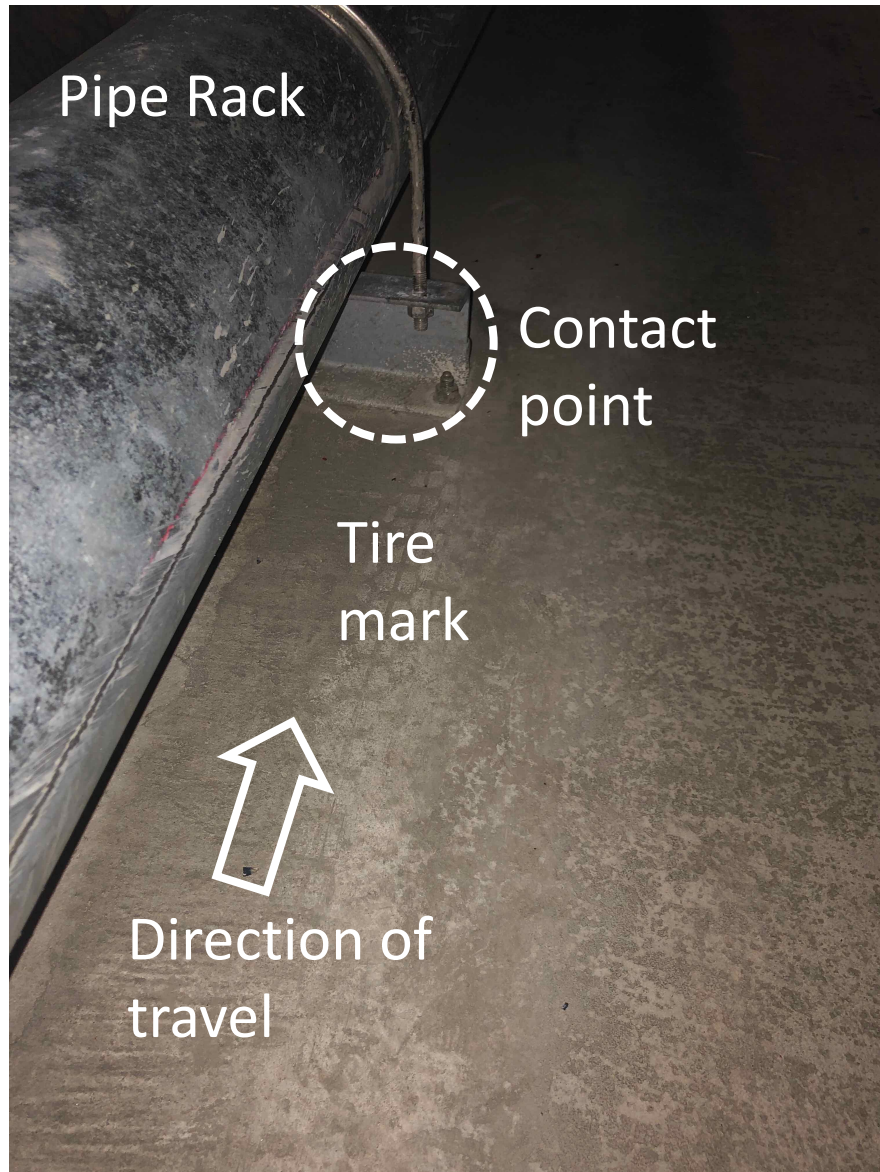
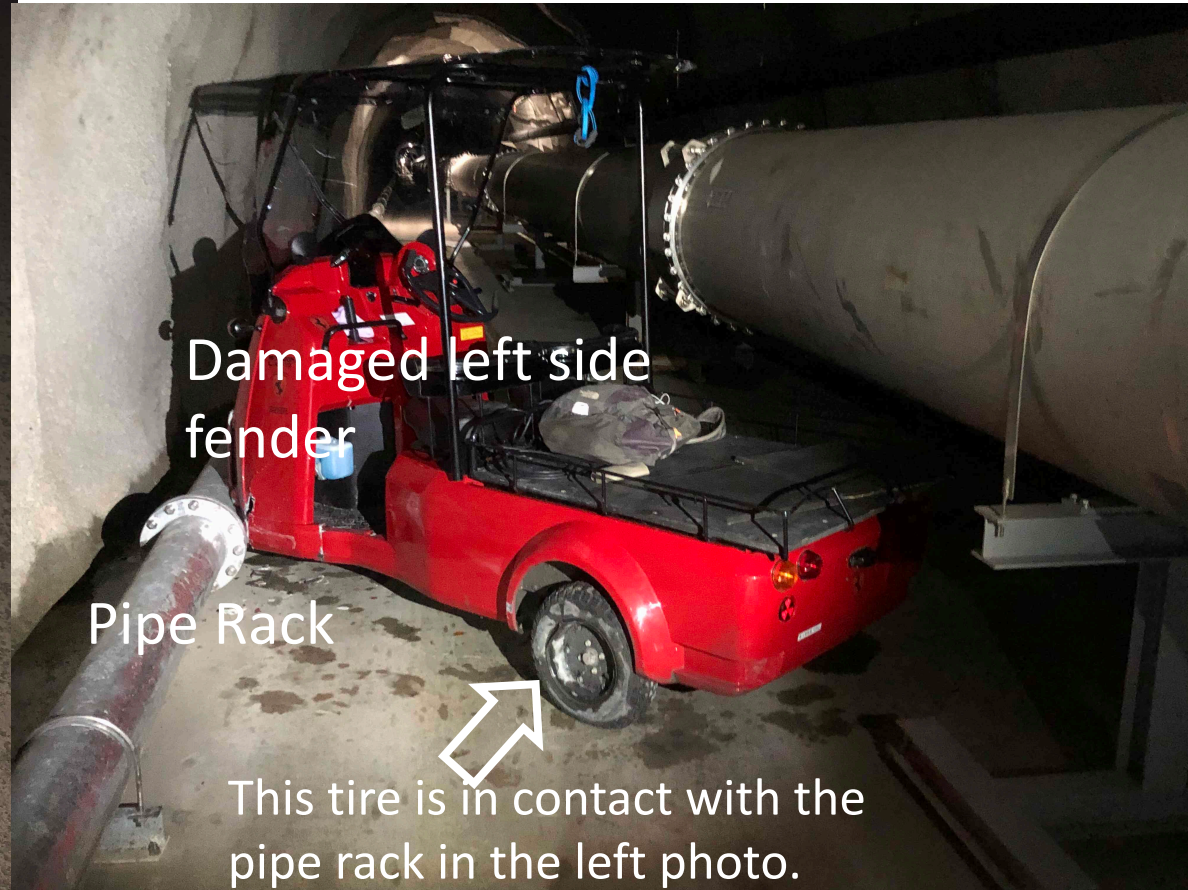
# Situation immediately after the accident

- ✓ Accidents of mobile vehicle called T-3 in the tunnel:
  - Left rear wheel of a three-wheeled electric vehicle struck a drainage pipe rack.
  - The impact of the collision caused the vehicle to rotate, and operator and three passengers sustained minor bruises.
- ✓ Occurred date: 2021 Sept. 28 ~1 PM
- ✓ Location of the accident:
  - ~1845 m from center area in Y-arm tunnel
- ✓ Factors behind the accident:
  - Vehicle operator was getting impatient to hurry up and resume work after lunch.
  - Because of this, no attention was paid to driving on narrow pass between drainage pipe rack and vacuum duct.

- ✓ Re-train vehicle operator in safety.
- ✓ Compliance with passenger capacity.
- ✓ Installation of signs to pay attention between pipe rack and vacuum duct.
- ✓ Increased lighting in tunnels.

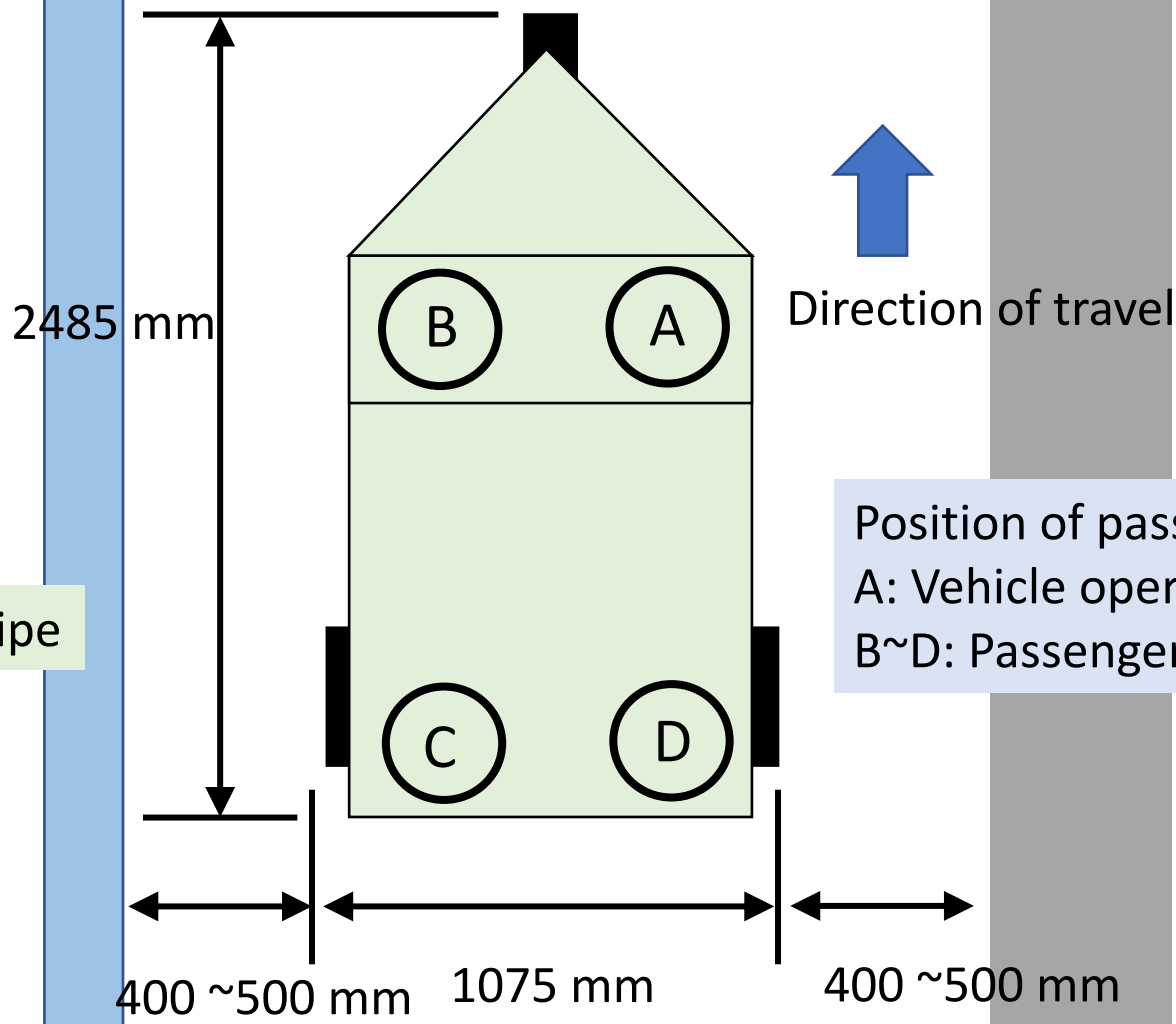
# Illustration of the situation

Position of passenger on board  
A: Vehicle operator  
B~D: Passenger

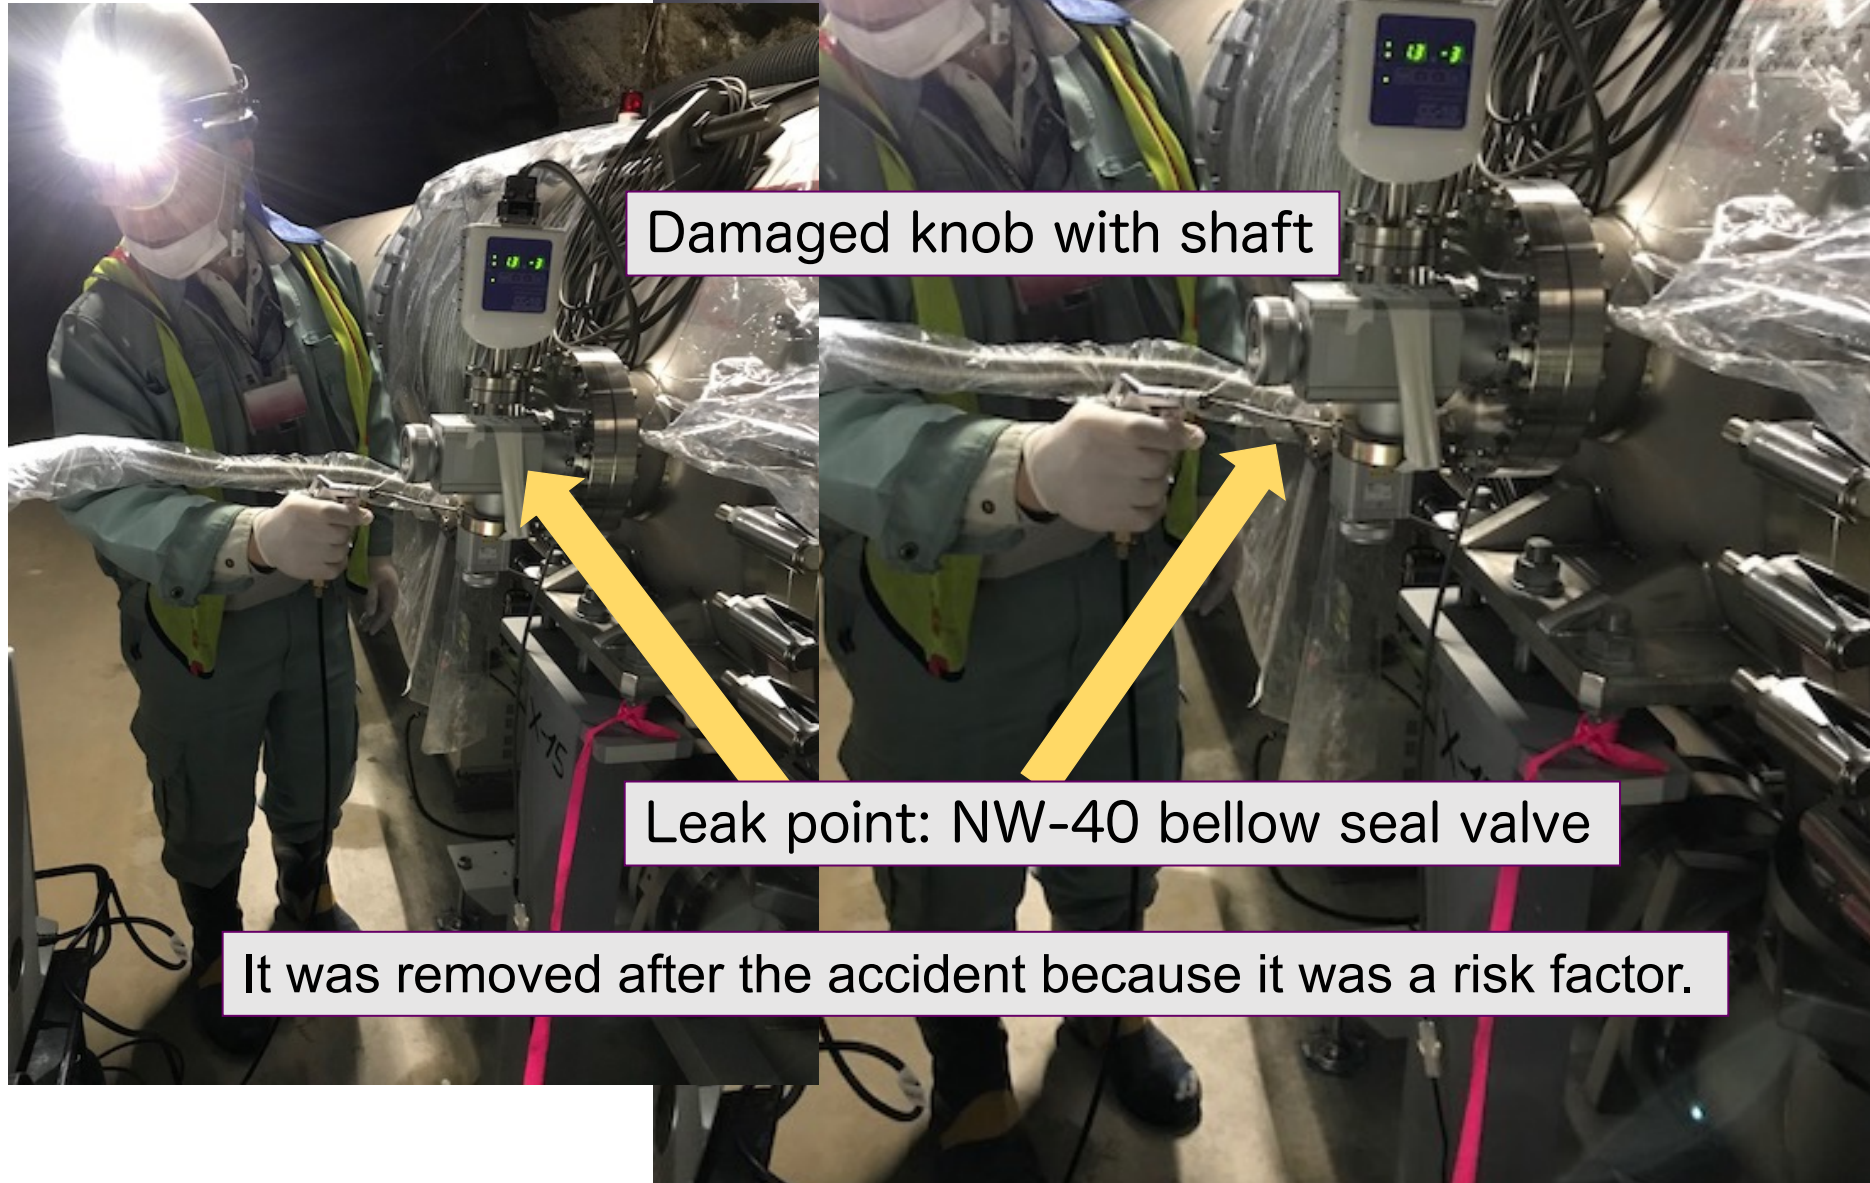
- Valve knob and shaft were deformed

We assumed side mirror on T-3 hit the valve!

- Leaking from valve plug seal. (Valve was closed)
- Tunnel air was breathed in through a simple sealing section of the air supply system for vacuum breaking that was connected to the valve.

Damaged knob with shaft

Leak point: NW-40 bellow seal valve

It was removed after the accident because it was a risk factor.

- ✓ Valve and some components were removed after the incident.
- ✓ Installation of signs to call attention to the situation.

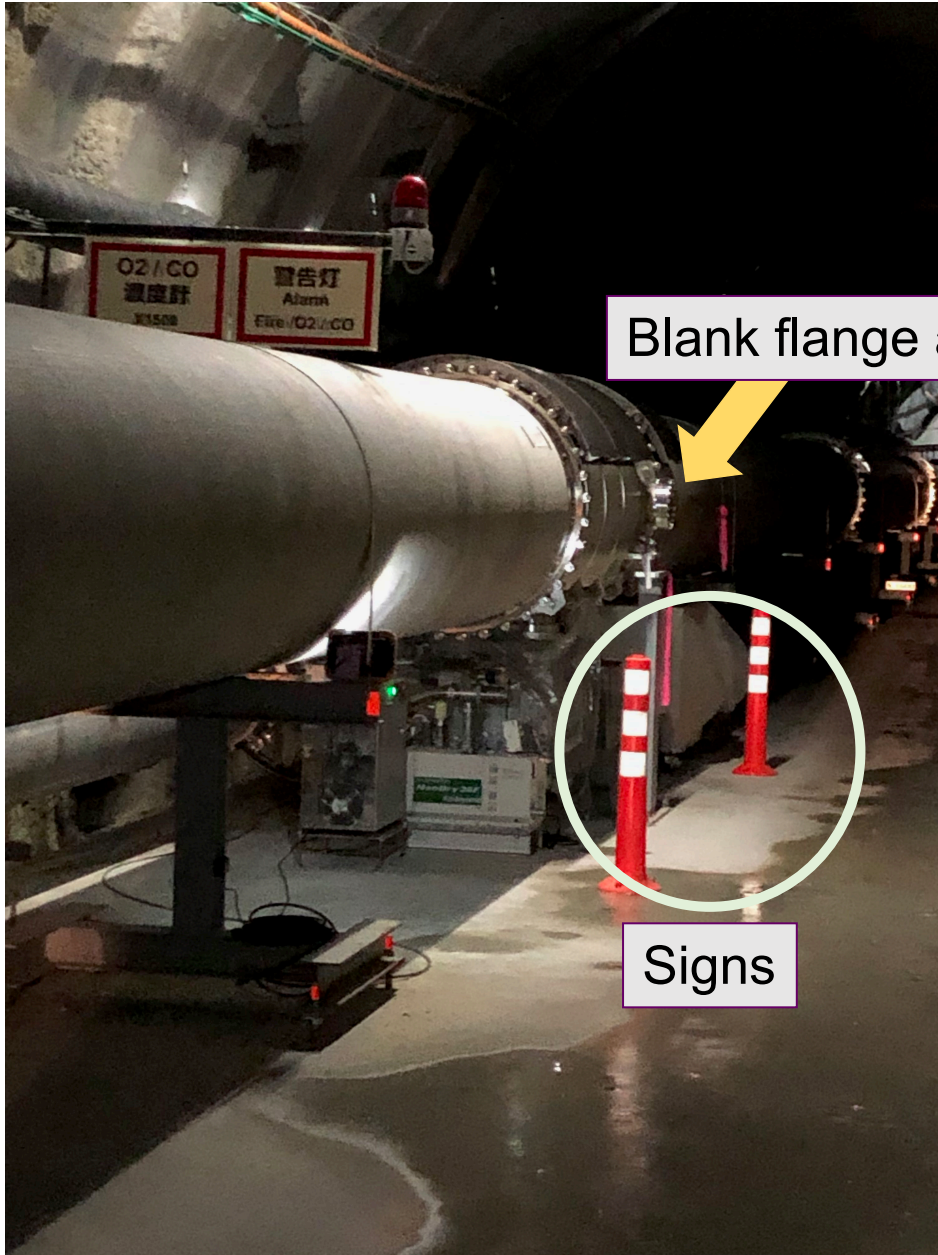
# The current status of near X-15

Blank flange after removed valve.
