Comments from PAB report 2020

Comments from PAB report 2019

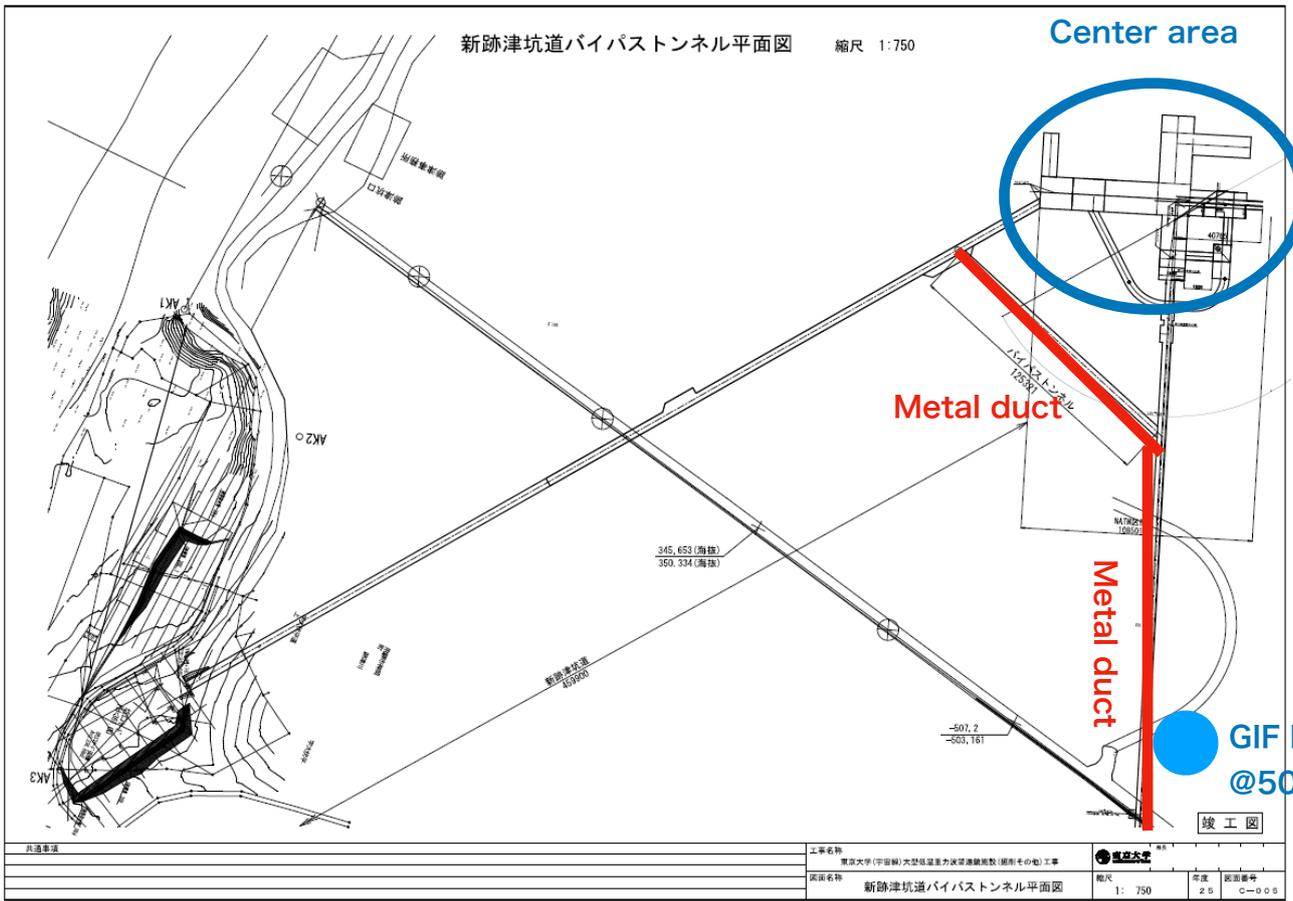
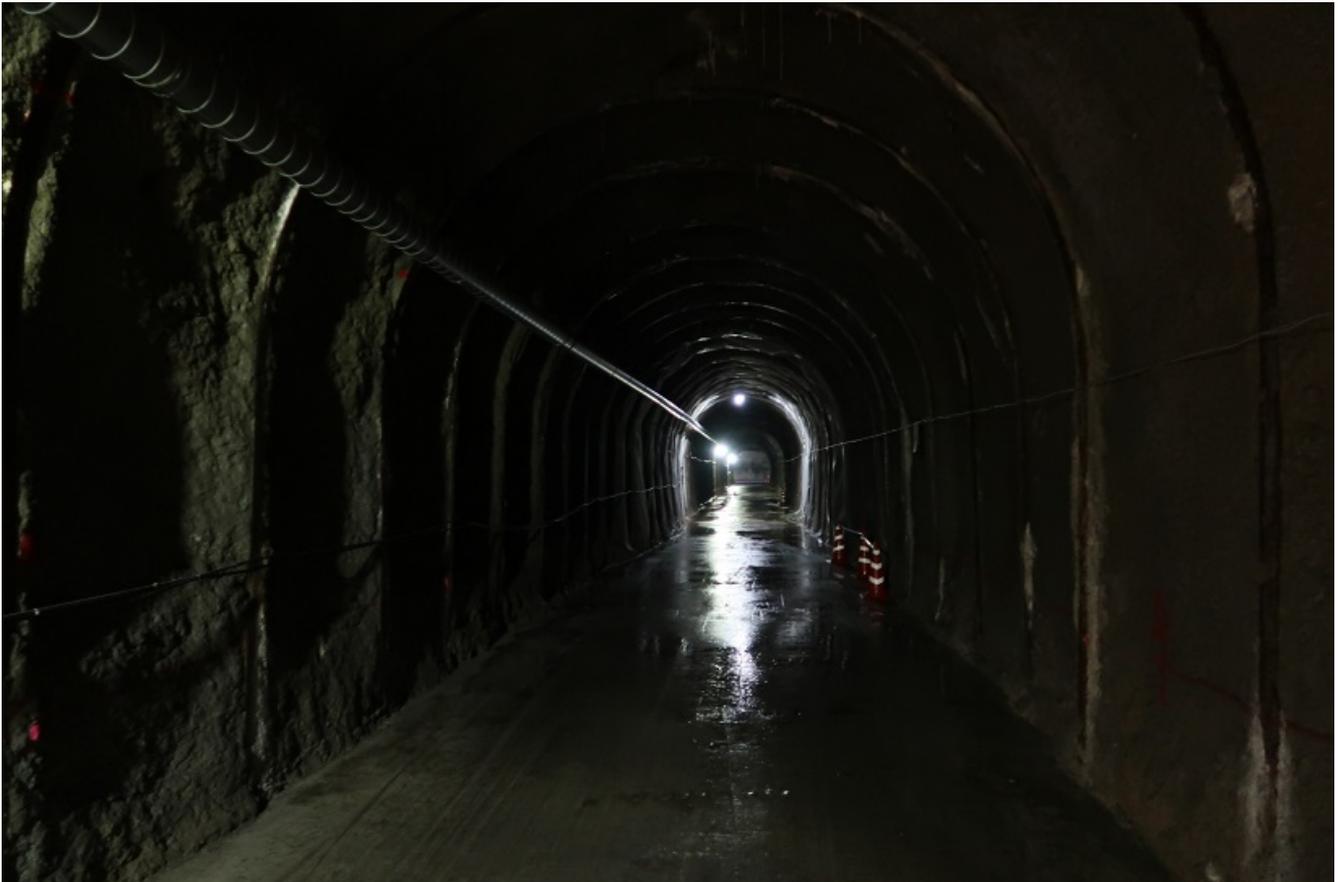
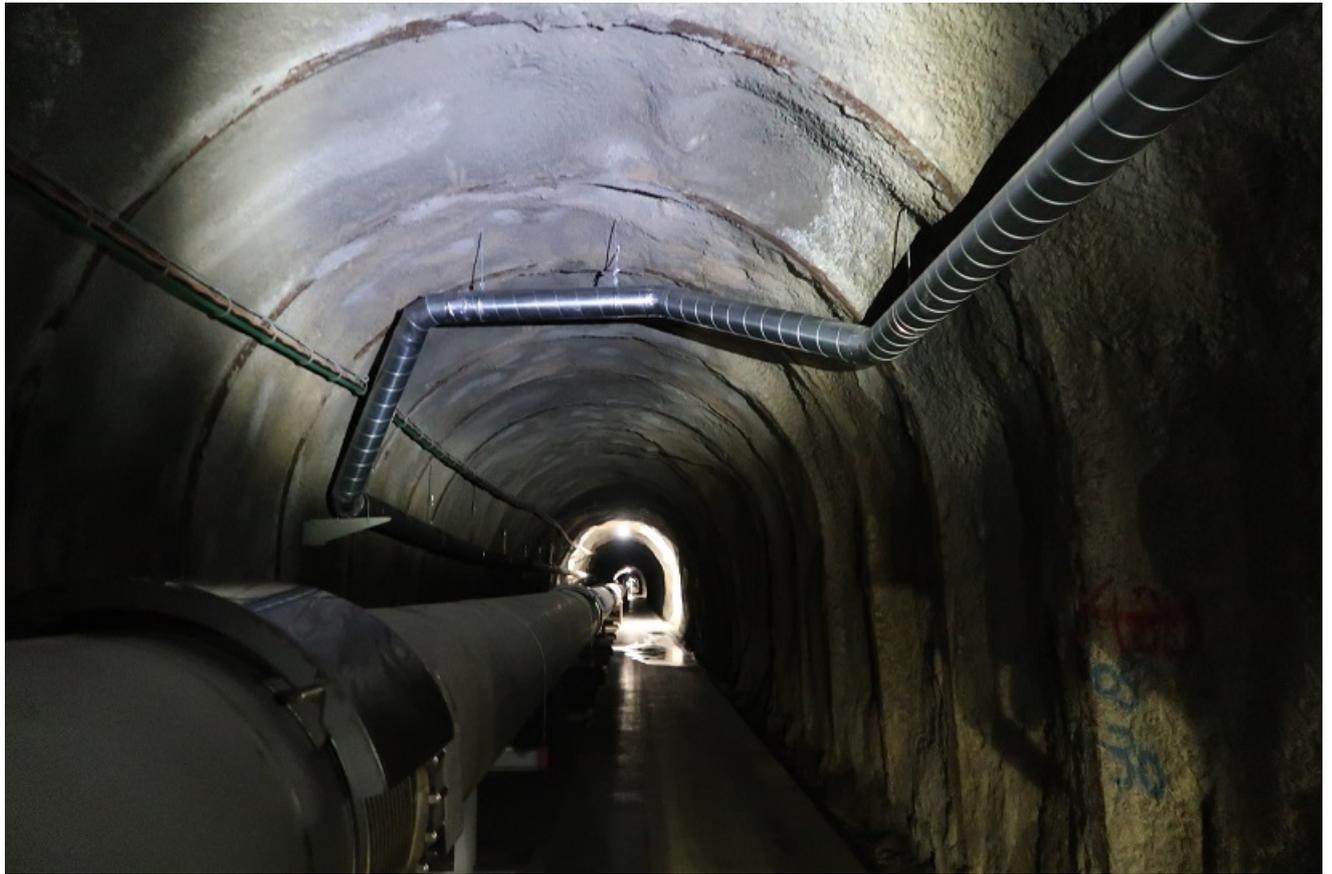
- **Recommendation:** The safety of KAGRA personnel and the instrument is of the highest priority. **KAGRA should work to quickly complete the ductwork needed to bring fresh outside air to the X end station.** KAGRA management should continue to work to address the other items the PAB notes above and the committee looks forward to hearing about further progress by the next meeting.

- The current status of safety recommendations in the PAB report 2019: Shown later.
- The ductwork for the Xend.
 - We have installed metal air ducts from the start point of the bypass tunnel to 600m in the Xarm tunnel.
 - The metal ducts are connected to the existing air ducts that extend to Xend.
 - New air ducts for Xend will not be affected by fires both in the center area and at the laser source of the geophysical interferometer at 500m in the Xarm tunnel.
 - The GIF laser source and related equipment are considered to be the most possible cause of the fire in the Xarm tunnel. That's the reason why the metal ducts were extended to 600 meters.

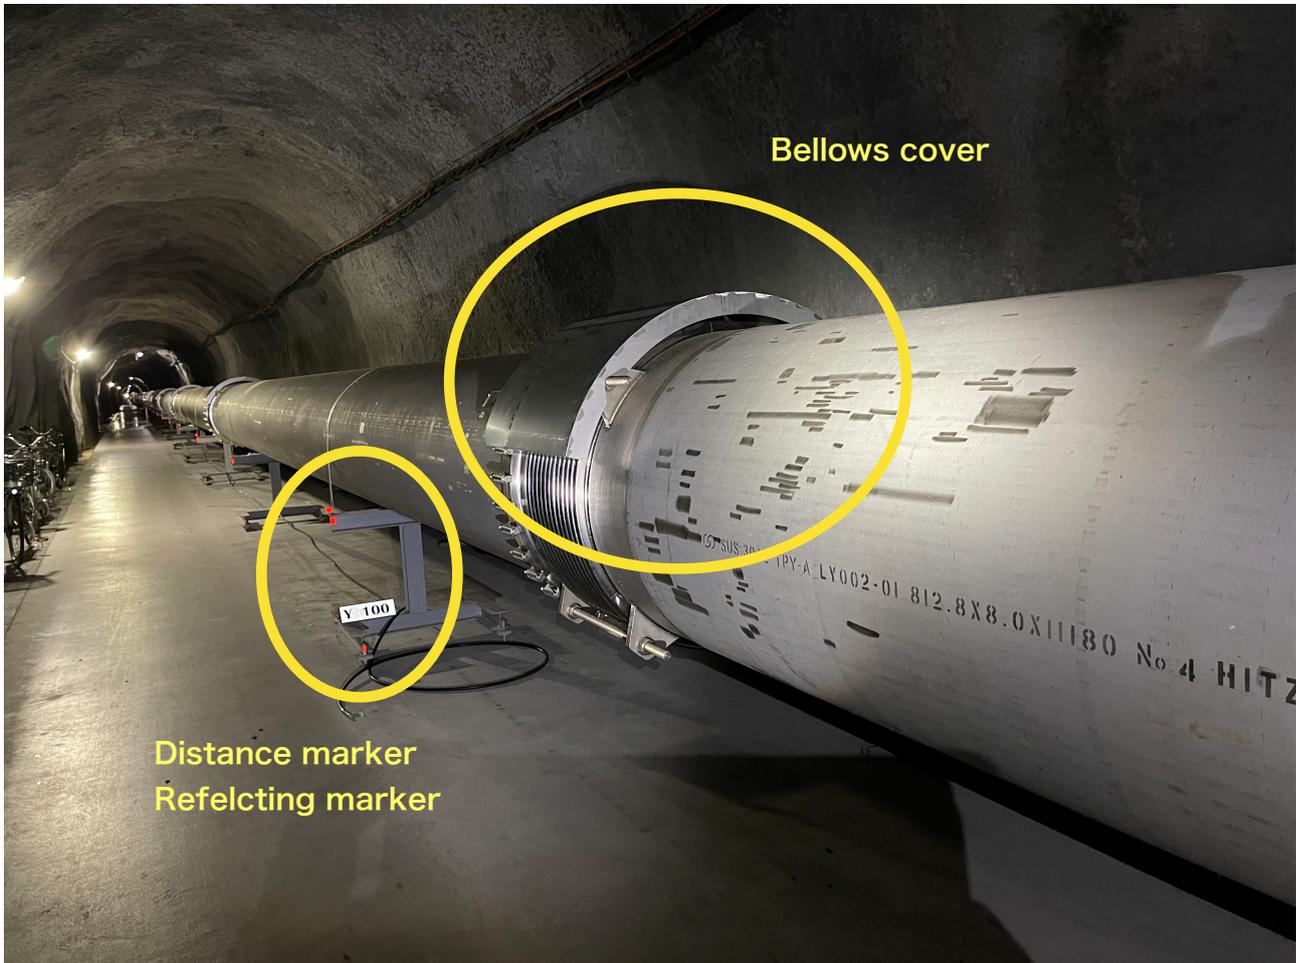
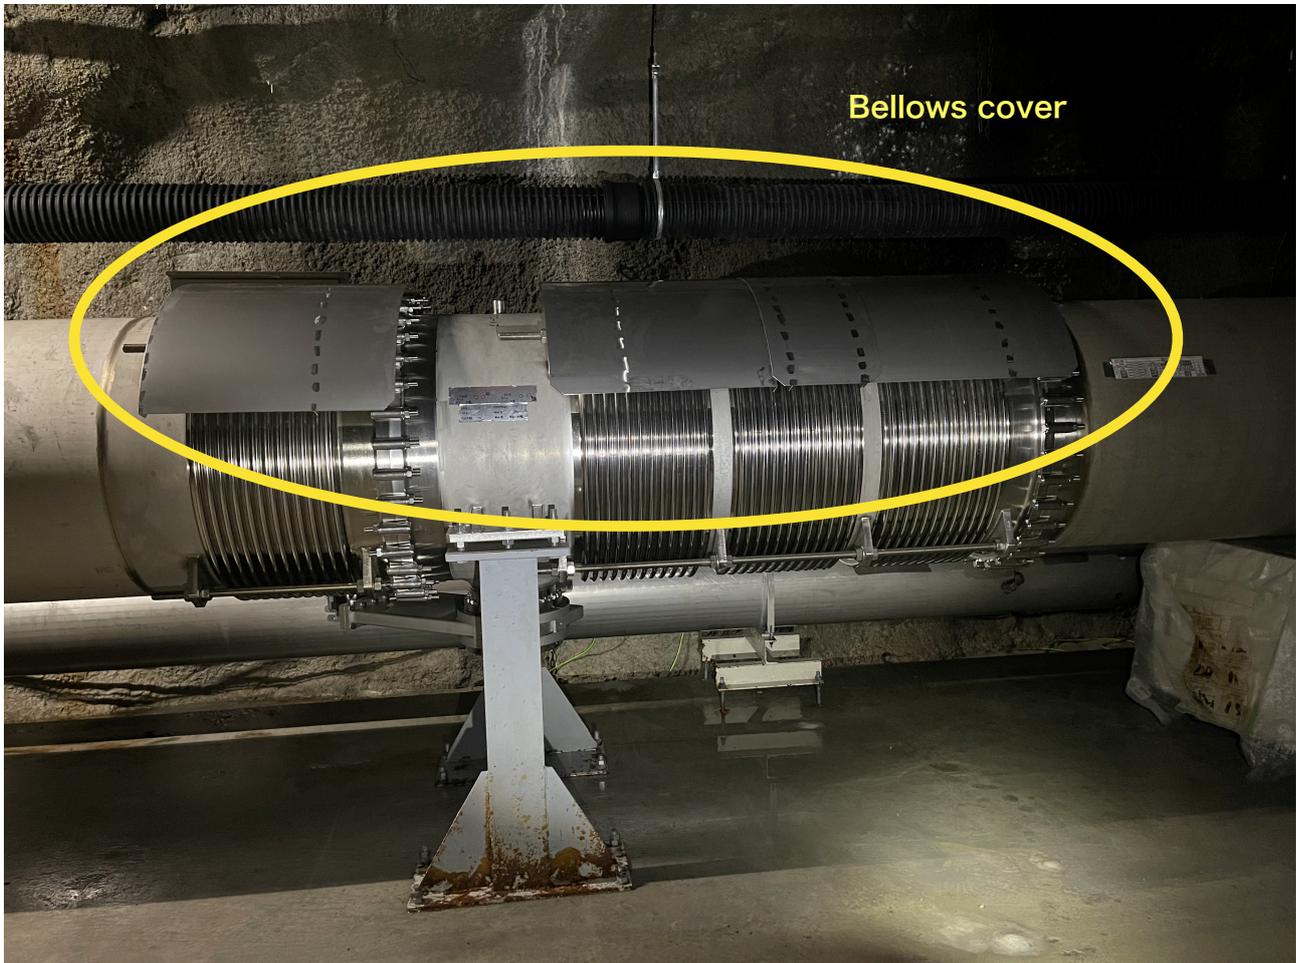
5. Seismic motion of the tunnel has been observed. One example the PAB visitors to the site heard was that a falling chunk of concrete barely missed one of the 0.5 mm thick bellows. This indicates that there is an urgent need to [protect these bellows joints](#).

1. Answer: We have done.
