**IOO (General)**

shinji.miyoki - 18:57 Tuesday 24 March 2020 (13794)

**Half Wave Plate was damaged and smoke in the REFL table.**

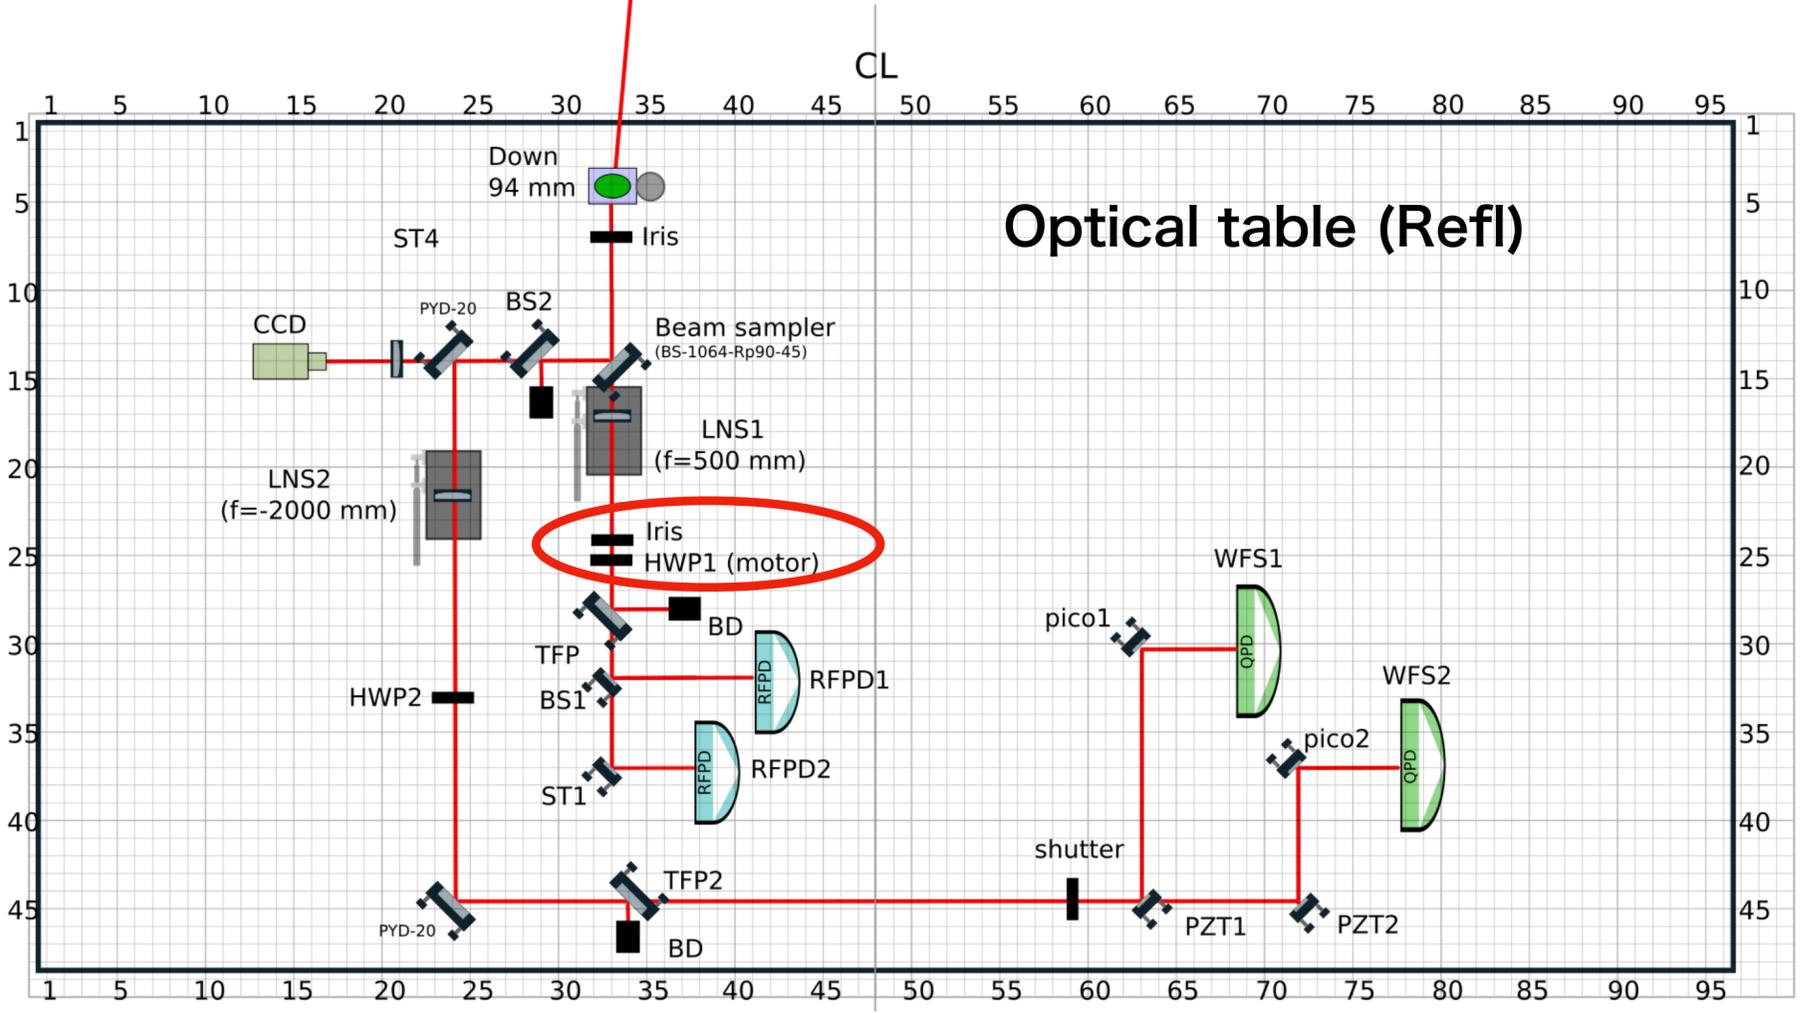
1) We found that a fixing ring for a half wave plate just after the periscope was "burnt" and melted as the first attached image0-1. Especially, the slight transparent area shape is same shape on the REFL camera in the control room. This ring is made of plastic. We guessed this burning occurred by strong IR power. We replaced this HWP and the rotating optical part with new one.

- **Date; 2020 March 24**
- **What happened;**
  - **Strong scattering in the Refl optical table was observed.**
  - **We inspected the Refl optical table and we found that a fixing ring for a half-wave plate was burnt.**
- **Reason;**
  - **High power (~5W) IR laser hit the fixing ring made of plastic.**
- **Response;**
  - **We replaced HWP and inserted an iris in front of HWP to protect from the laser. Finally, the ring was changed to a metal ring.**

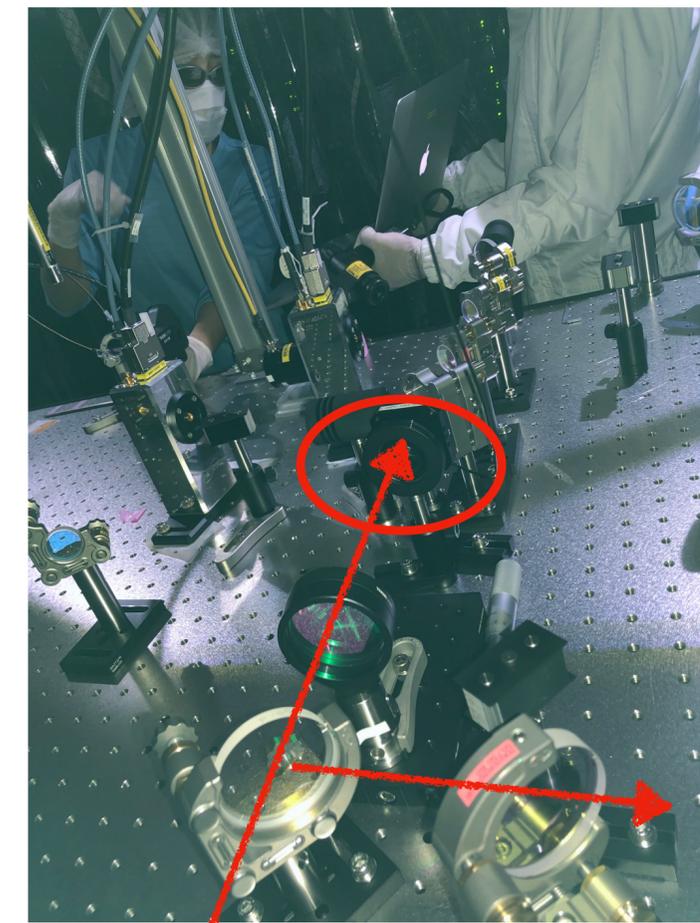
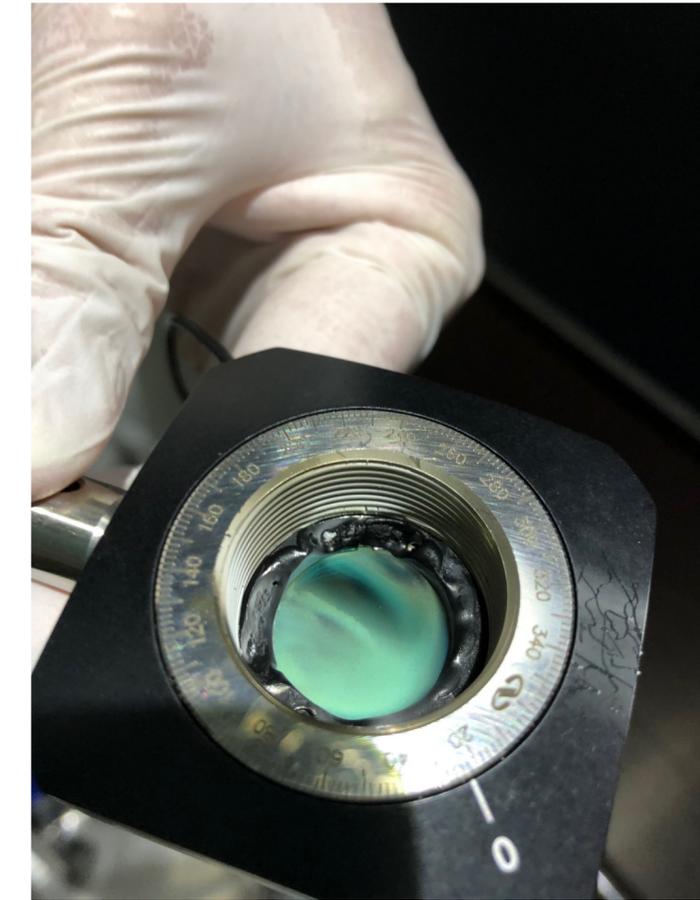
In addition to this, we found a strong scattering on the surface of a beam splitter just after the HWP and PBS plate set. There seemed to be several point scattering sources on the surface by using IR viewer. We wiped it by acetone and ethanol. Point like scattering source vanished, however, we still saw smoky image where the IR hit. So we changed this BS itself with a new one. However, we saw the same smoky image. We concluded that this is due to quality of this BS. However, we never see such smoky image on for example lens. So we should select better BS in the future.

In the same manner, the two mirrors had the possibility to be smoked by smoke from HWP. So we also wiped their surface by using acetone and ethanol. We just believed they are cleaned now. Also we found a smoky coating on the optical table surface around the HWP. When I wiped them by ethanol, they were removed. So, this is also because of HWP burning. According to my memory, this smoky coating on the surface did exist in 2019. I and Miyakawa-kun discussed the possibility about this burning started from the high power injection test in FPMI configuration in 2019.
